Release Notes for Version 07.1.24 Operating Systems for the HP ProCurve Routing Switch 9304M and 9308M with Redundant Management (MII and MIV)

5969-2390
Edition 1
September 2001

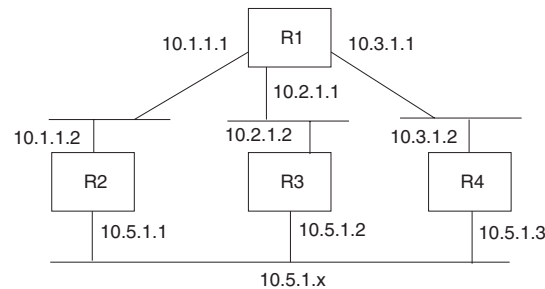
- **IPX** – Packet buffers were freed twice for forwarded IPX packets.
- **OSPF** – If a static route was configured with a non-zero host portion and then was redistributed into OSPF, the route could not later be removed by the **no redistribute static** command.
- **OSPF** – If an OSPF interface that was down was configured with a priority of 0 and was set to the passive mode afterwards, the HP device incorrectly advertised the attached network as a reachable route in OSPF.
- **OSPF** – In some cases, a learned route could be preferred over a directly connected route. In the following example, R3 could incorrectly select a path through R2 or R4 even though the path through R3 was the directly connected path.
