Procedure For USB Firmware Upgrade

(For HP MDTV's (MD5020, MD5820, MD5880, MD6580) Rev. 03/17/06

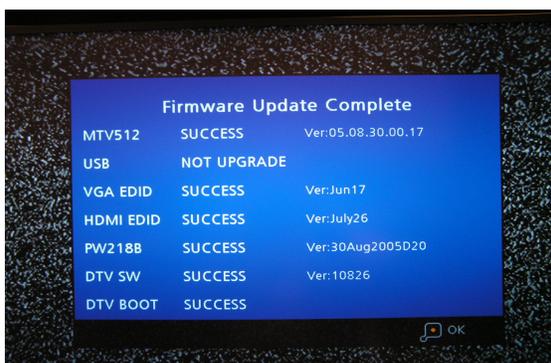
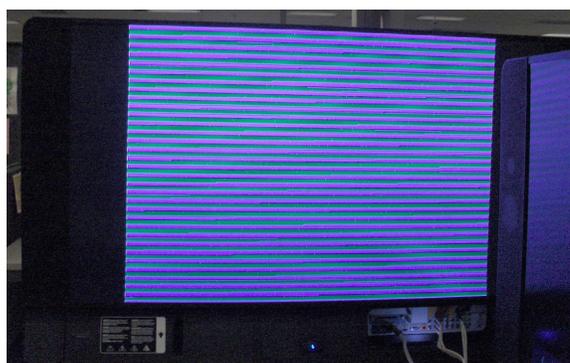
Horizontal banding or Half screen banding with HDMI inputs only:

Issue: Condition #1 – turning on the TV after upgrading the firmware should display the files that were upgraded (Firmware Upgrade Complete screen), however the screen may appear for a split second before the horizontal banding appears (HDMI cable connected to TV).

Resolution: Remove the HDMI cable and reinsert it to the other HDMI port. The image should appear. You can then reinsert it back to the other port. The firmware needs to resynchronize the connection with the HDMI ports after the upgrade. This will only need to be done once.

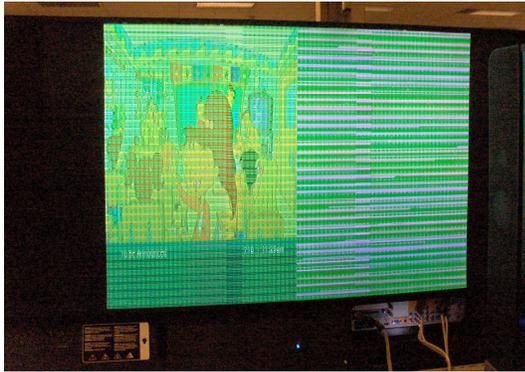
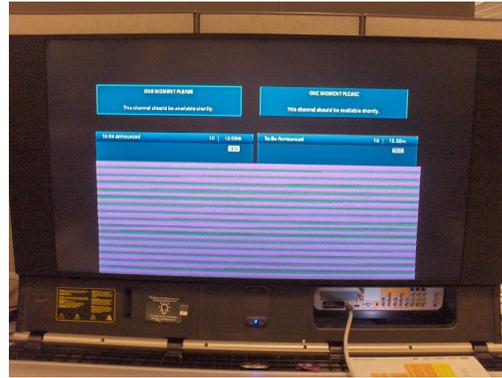
Issue: Condition #2 - – turning on the TV after upgrading the firmware displays the files that were upgraded (Firmware Upgrade Complete screen), however changing the channels from HD to SD results in an image with banding either in full screen mode or half screen mode.

Resolution: Remove the HDMI cable and reinsert it to the other HDMI port. The image should appear. You can then reinsert it back to the other port. The firmware needs to resynchronize the connection with the HDMI ports after the upgrade. This will only need to be done once.

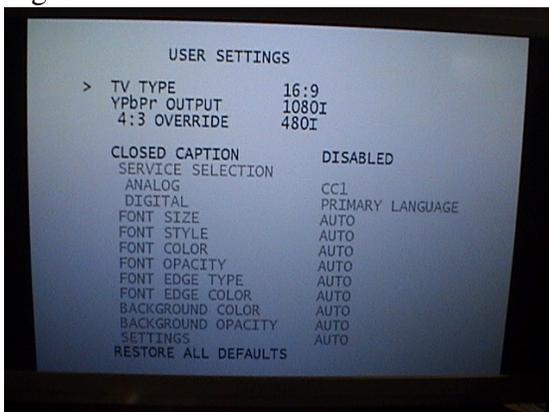
Figure 1

Issue: Image flickers when changing from HDTV to SDTV to DTV to SDTV channels. Sometimes the TV is able to lock onto the channel, other times it continuously flickers between channel changes.

1. Turn off the STB.
2. Press the STB Menu button. See the attached picture "Figure 1".
3. Press the STB down-arrow button twice to reach the 4:3 Override setting.
4. Press the STB right-arrow button to change 4:3 override to OFF. See the attached picture "Figure 2".
5. Turn off the STB.
6. Turn on the STB.
