Procedure For USB Firmware Upgrade

(For HP MDTV's (MD5020, MD5820, MD5880, MD6580) Rev. 03/17/06

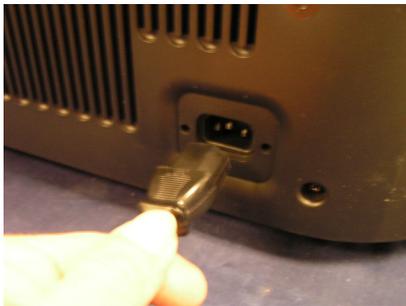
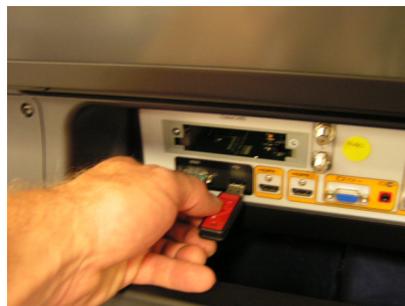
- Firmware loads automatically. This upgrade process is indicated by three LED's on the front panel that flash sequentially from Left to Right. The process will take about 30 minutes. Sometimes the sequential flashing will stop momentarily, but should re-start automatically.

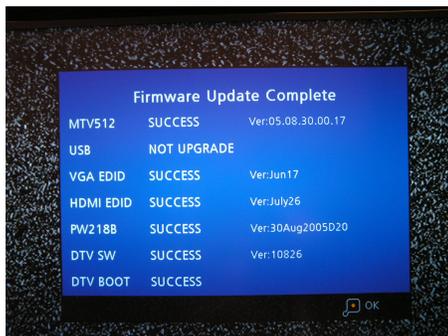
- Turn-ON TV. The firmware update screen should appear and indicate that your new firmware was loaded with “Success”. Check for the correct firmware version. If a message displays “NOT UPGRADE” – this indicates the file(s) did not have to be upgraded. If everything has updated correctly, follow the on screen display instructions to return the TV to normal use.
