Release Notes:

Version Q.11.02 Software

for the ProCurve Series 2510 Switches

Release Q.11.02 supports the ProCurve Switch 2510-24 (J9019A)

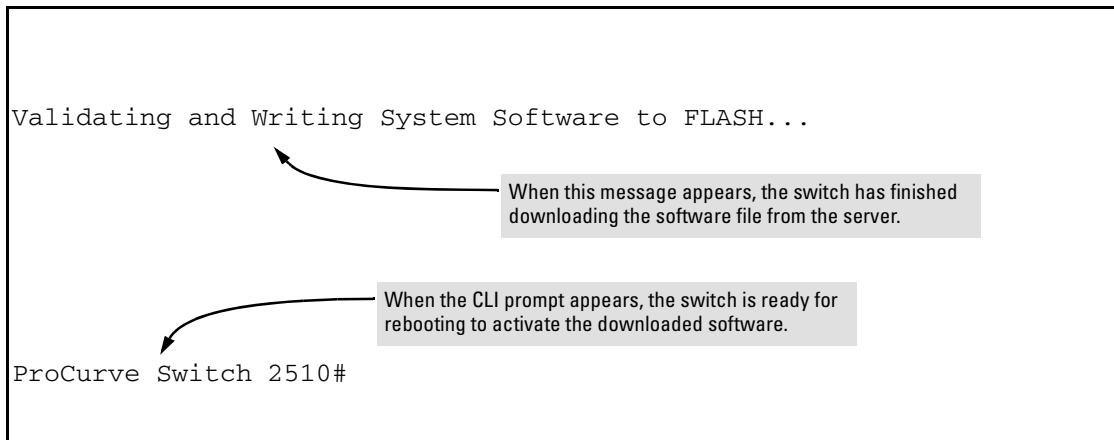
2. When the switch finishes downloading the software file from the server, it displays the progress message shown in figure 1. When the CLI prompt re-appears, the switch is ready to reboot to activate the downloaded software:

Figure 1. Message Indicating the Switch Is Ready To Activate the Downloaded Software
