Release Notes: Version I.08.105 Software *for the ProCurve 2800 Series*

Release I.08.105 supports these switches:

- ProCurve Switch 2824 (J4903A)
- ProCurve Switch 2848 (J4904A)

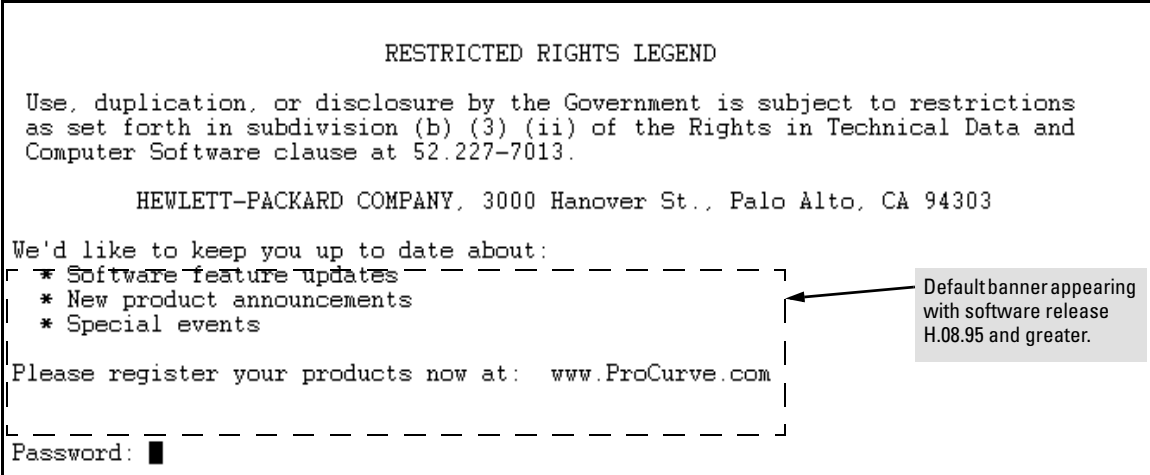
Figure 4. The Default Login Banner

Note: The switch's Web browser interface does not display the default banner.

When a system operator begins a login session, the switch displays the banner above the local password prompt or, if no password is configured, above the **Press any key to continue prompt**. Entering a correct password or, if no password is configured, pressing any key clears the banner from the CLI and displays the CLI prompt. (Refer to figure [Figure 4](#) on page 27.)

configured). Following entry of the correct username/password information (or if no username/password is required), the switch then displays either the Registration page or the switch's home page. Note that if the banner feature is disabled or if the switch is using the factory-default banner shown in figure [Figure 4](#), then the banner page does not appear in the Web browser when an operator initiates a login session with the switch.
