## Release Notes: Version I.08.87 Software *for the ProCurve 2800 Series*

Release I.08.87 supports these switches:

- ProCurve Switch 2824 (J4903A)
- ProCurve Switch 2848 (J4904A)

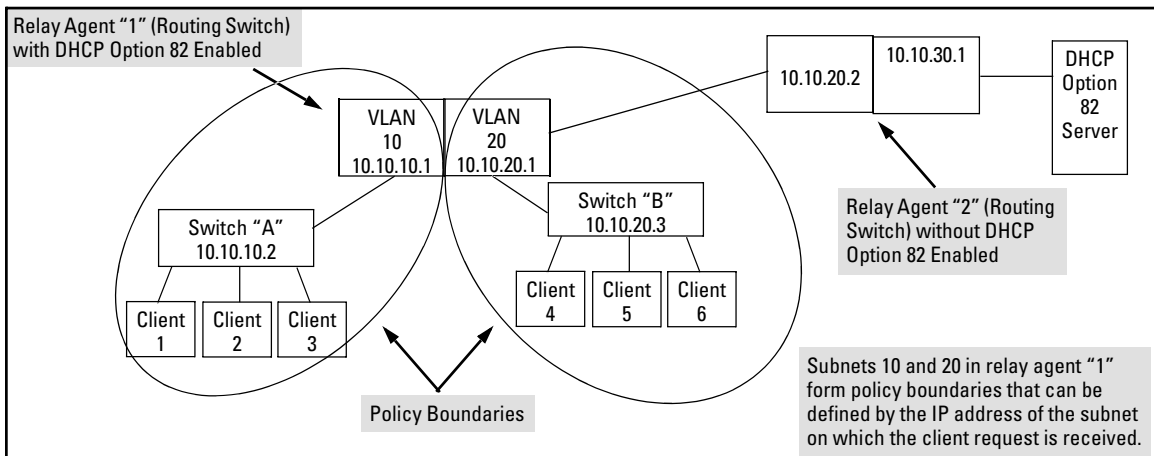
Figure 2. Example of a DHCP Option 82 Application

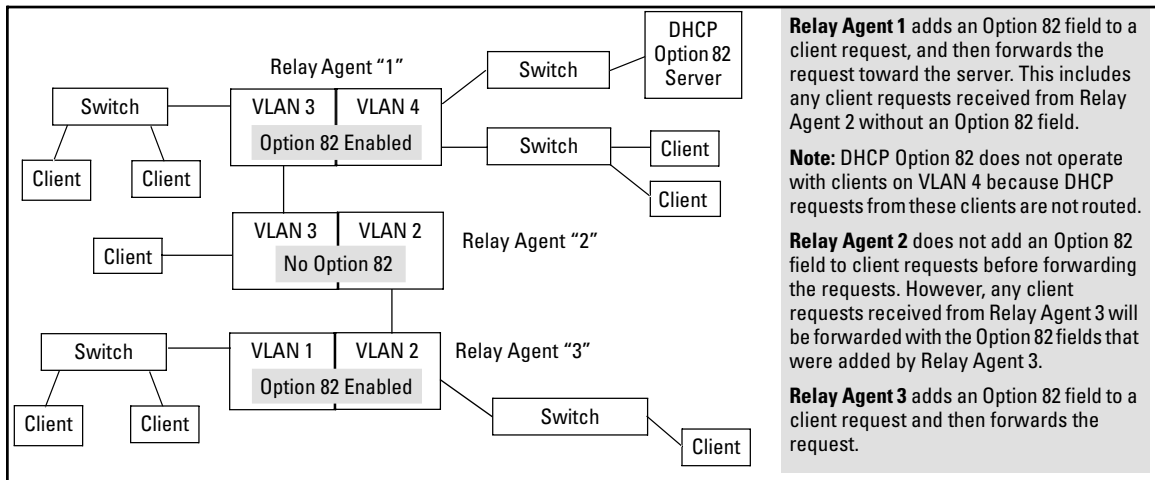
**General DHCP-Relay Operation with Option 82.** Typically, the first (primary) Option 82 relay agent to receive a client's DHCP request packet appends an Option 82 field to the packet and forwards it toward the DHCP server identified by the IP Helper address configured on the VLAN in which the client packet was received. Other, upstream relay agents used to forward the packet may append their own Option 82 fields, replace the Option 82 field(s) they find in the packet, forward the packet without adding another field, or drop the packet. (Intermediate next-hop routing switches without Option 82 capability can be used to forward—route—client request packets with Option 82 fields.) Response packets from an Option 82 server are routed back to the primary relay agent (routing switch), and include an IP addressing assignment for the requesting client and an exact copy of the Option 82 data the server received with the client request. The relay agent strips off the Option 82 data and forwards the response packet out the port indicated in the response as the Circuit ID (client access port). Under certain validation conditions described later in this section, a relay agent detecting invalid Option 82 data in a response packet may drop the packet.

**Figure 3. Example of DHCP Option 82 Operation in a Network with a Non-Compliant Relay Agent**

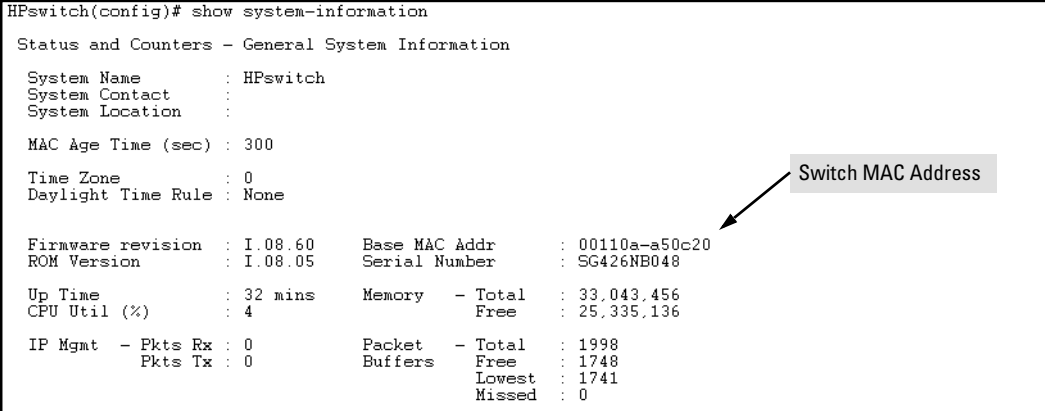
**Figure 4. Using the CLI To View the Switch MAC Address**

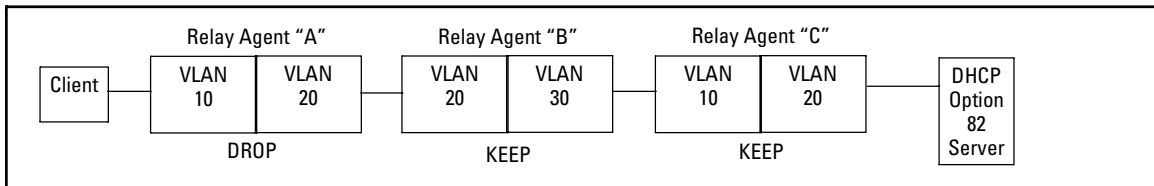
**Figure 6. Example Configured To Allow Only the Primary Relay Agent To Contribute an Option 82 Field**

The above combination allows for detection and dropping of client requests with spurious Option 82 fields. If none are found, then the drop policy on the first relay agent adds an Option 82 field, which is then kept unchanged over the next two relay agent hops ("B" and "C"). The server can then enforce an IP addressing policy based on the Option 82 field generated by the edge relay agent ("A"). In this example, the DHCP policy boundary is at relay agent 1.

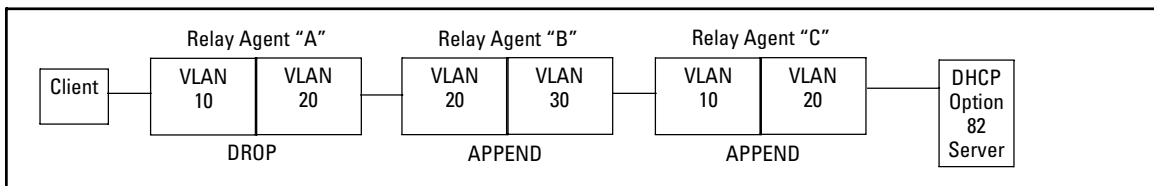
**Figure 7. Example Configured To Allow Multiple Relay Agents To Contribute an Option 82 Field**

This is an enhancement of the previous example. In this case, each hop for an accepted client request adds a new Option 82 field to the request. A DHCP server capable of using multiple Option 82 fields can be configured to use this approach to keep a more detailed control over leased IP addresses. In this example, the primary DHCP policy boundary is at relay agent "A", but more global policy boundaries can exist at relay agents "B" and "C".

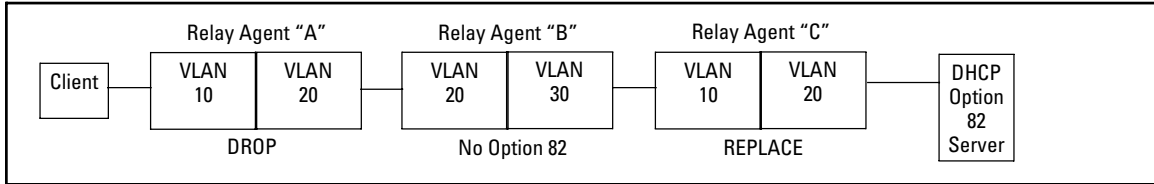
**Figure 8. Example Allowing Only an Upstream Relay Agent To Contribute an Option 82 Field**

Like the first example, above, this configuration drops client requests with spurious Option 82 fields from clients on the edge relay agent. However, in this case, only the Option 82 field from the last relay agent is retained for use by the DHCP server. In this case the DHCP policy boundary is at relay agent "C". In the previous two examples the boundary was with relay "A".
