Release Notes:

Version E.10.37 Software

for the ProCurve Series 5300xl Switches

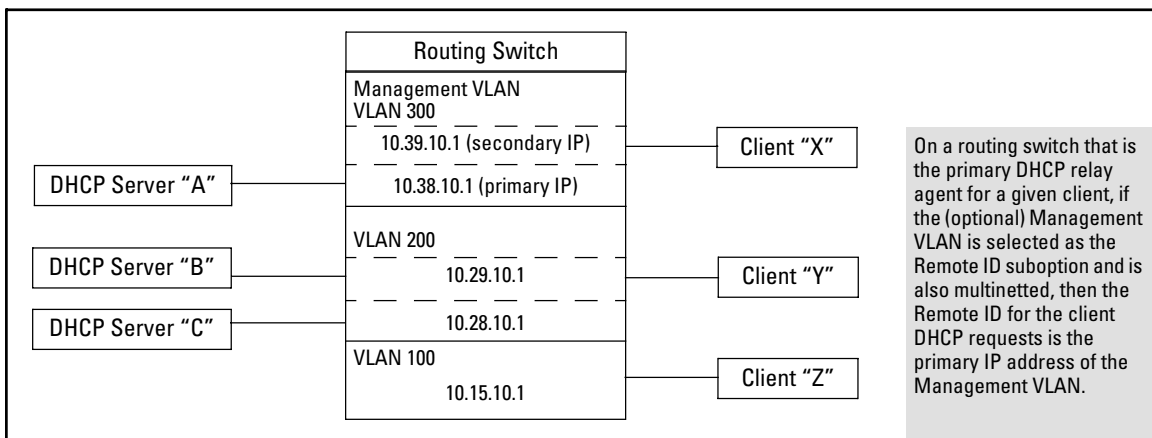
In the routing switch in figure 1, option 82 has been configured with **mgmt-vlan** for the Remote ID.

```
ProCurve(config)# dhcp-relay option 82 append mgmt-vlan
```

Figure 1. DHCP Option 82 When Using the Management VLAN as the Remote ID Suboption

The resulting effect on DHCP operation for clients X, Y, and Z is shown in [table 1](#).

Table 1. DHCP Operation for the Topology in Figure 1
