# Release Notes:

## Version E.10.44 Software

*for the ProCurve Series 5300xl Switches*

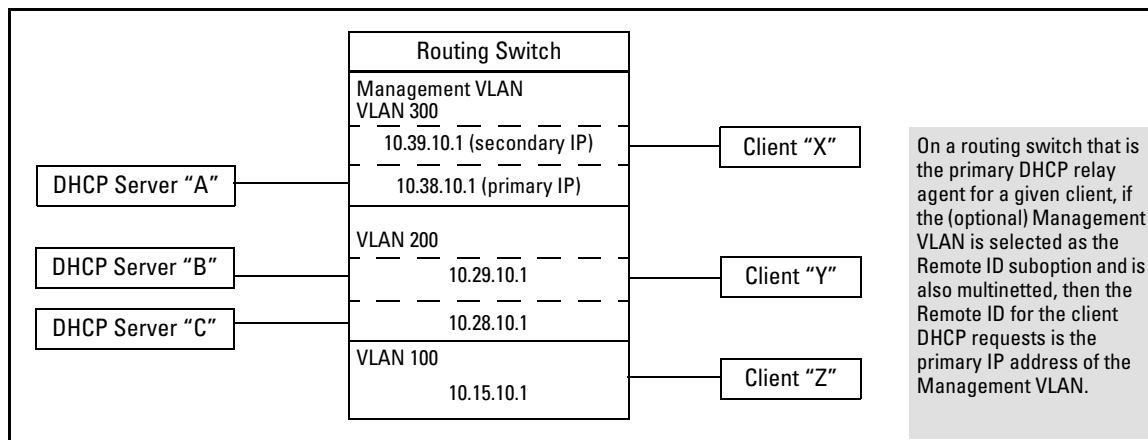
**Figure 2. DHCP Option 82 When Using the Management VLAN as the Remote ID Suboption**

In the routing switch in figure 1, option 82 has been configured with **mgmt-vlan** for the Remote ID.

```
ProCurve(config)# dhcp-relay option 82 append mgmt-vlan
```

The resulting effect on DHCP operation for clients X, Y, and Z is shown in [table 1](#).

**Table 1. DHCP Operation for the Topology in Figure 2**
