## Release Notes:

### Version E.10.52 Software

*for the ProCurve Series 5300xl Switches*

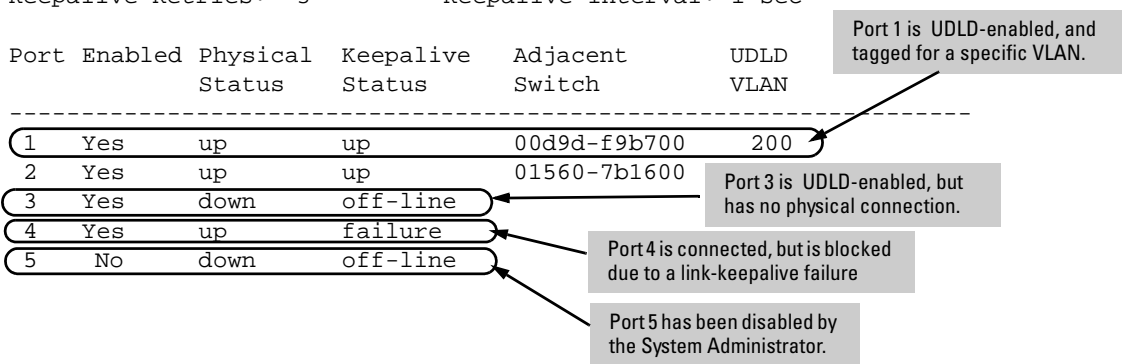
Port	Enabled	Physical Status	Keepalive Status	Adjacent Switch	UDLD VLAN
1	Yes	up	up	00d9d-f9b700	200
2	Yes	up	up	01560-7b1600	
3	Yes	down	off-line		
4	Yes	up	failure		
5	No	down	off-line

**Figure 8. Example of UDLD Information displayed using Show Link-Keepalive Command**

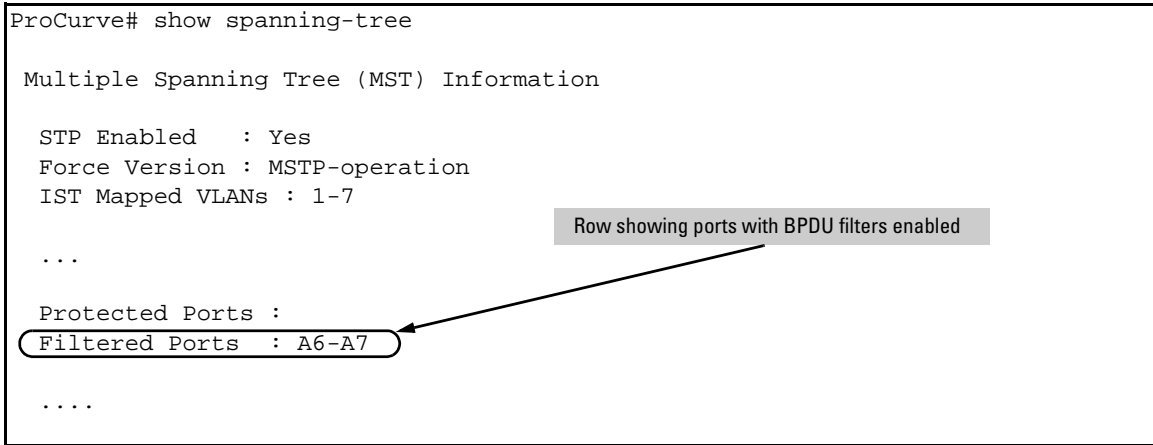
Protected Ports :
Filtered Ports   : A6-A7
....
```

**Figure 12. Example of BPDU Filtered Ports Field in Show Spanning Tree Command**

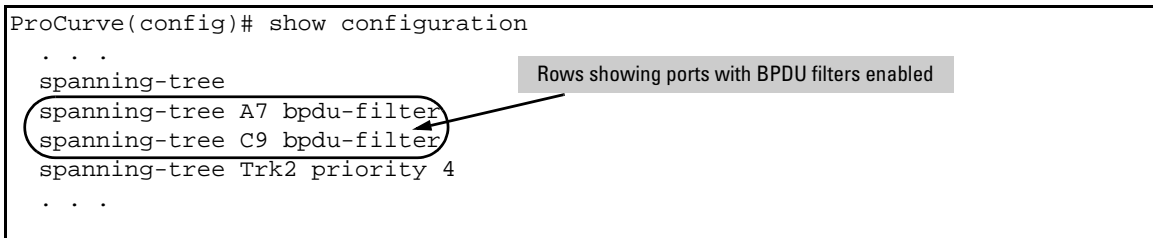
The BPDU filter mode adds an entry to the spanning tree category within the configuration file.

```
ProCurve(config)# show configuration
. . .
spanning-tree
spanning-tree A7 bpdu-filter
spanning-tree C9 bpdu-filter
spanning-tree Trk2 priority 4
. . .
```

**Figure 13. Example of BPDU Filters in the Show Configuration Command**

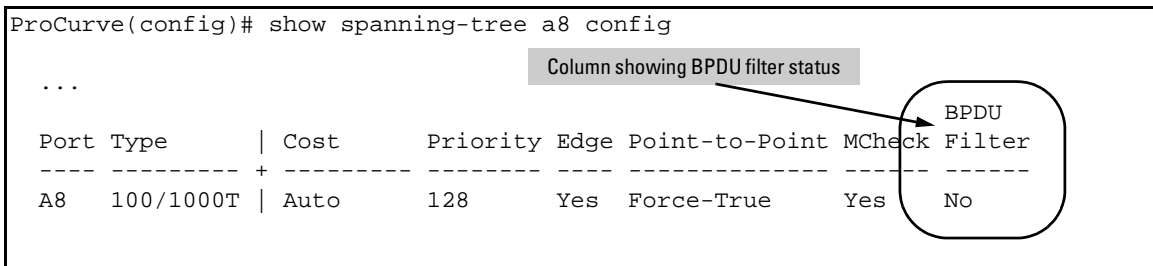
The **spanning-tree show < port> configuration** command displays the BPDU's filter state.

Port Type      | Cost      Priority Edge Point-to-Point MCheck Filter
-----+-----
A8 100/1000T | Auto     128    Yes  Force-True   Yes   No
```

**Figure 14. Example of BPDU Filter Status in Show Spanning Tree Configuration Command**
