Release Notes:

Version E.10.67 Software

for the ProCurve Series 5300xl Switches

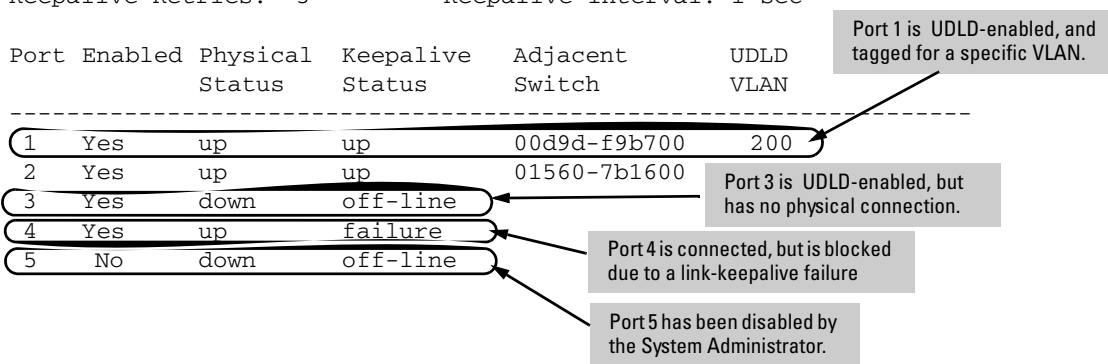
Port	Enabled	Physical Status	Keepalive Status	Adjacent Switch	UDLD VLAN
1	Yes	up	up	00d9d-f9b700	200
2	Yes	up	up	01560-7b1600	
3	Yes	down	off-line		
4	Yes	up	failure		
5	No	down	off-line

Figure 8. Example of UDLD Information displayed using Show Link-Keepalive Command

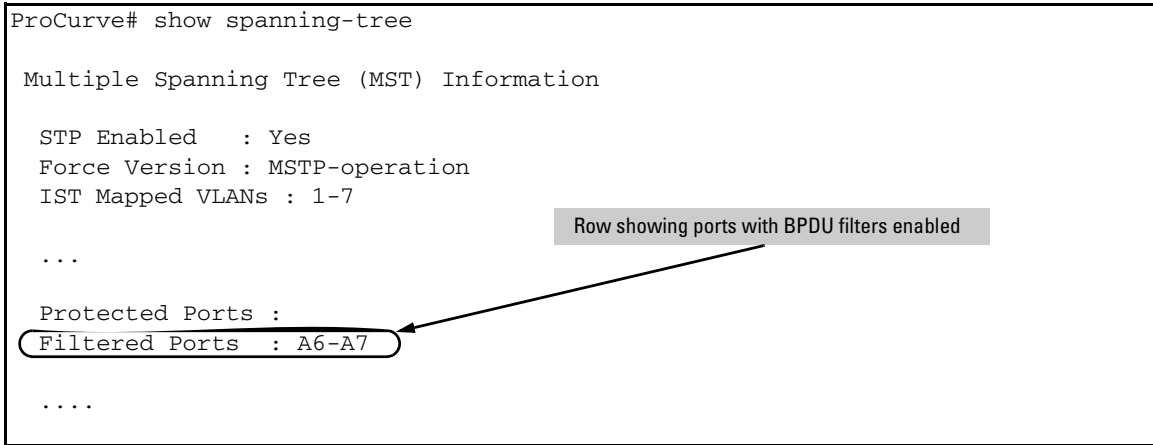
Figure 22. Example of BPDU Filtered Ports Field in Show Spanning Tree Command

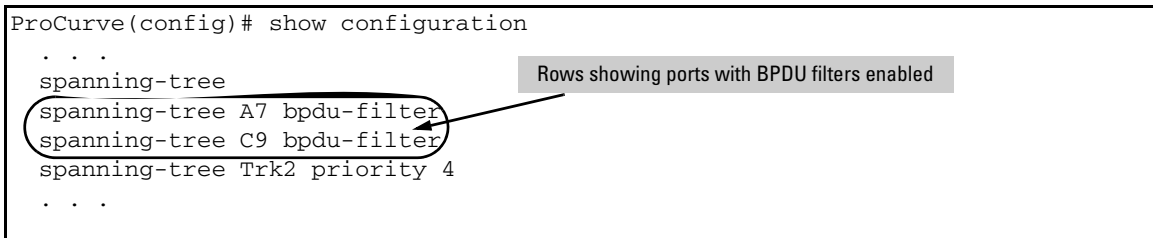
The BPDU filter mode adds an entry to the spanning tree category within the configuration file.

Figure 23. Example of BPDU Filters in the Show Configuration Command

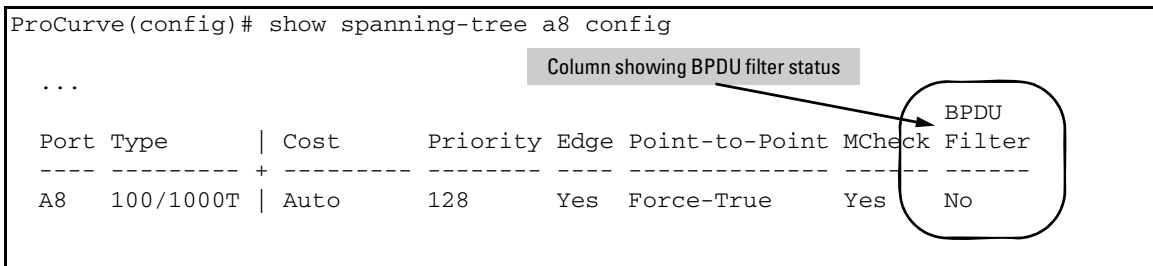
The **spanning-tree show <port> configuration** command displays the BPDU's filter state.

Figure 24. Example of BPDU Filter Status in Show Spanning Tree Configuration Command
