Release Notes:

Version E.07.37 Software

for the HP ProCurve Series 5300XL Switches

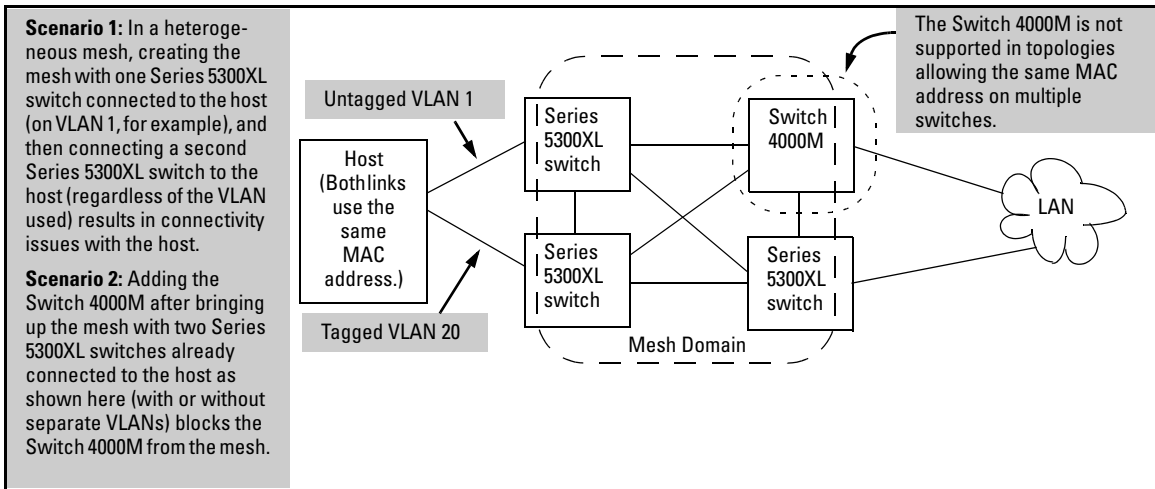
Figure 3. Example of an Unsupported Heterogeneous Topology Where Duplicate MAC Addresses Come Through Different Switches (Regardless of the VLANs Used)

When Series 5300XL switches running software release E.07.2x or greater are placed in backward-compatibility mode, they can operate in switch mesh domains that include HP ProCurve 1600M, 2400M, 2424M, 4000M, and 8000M switches. However, because these older switch models use a single-forwarding database, a heterogeneous domain must be free of duplicate MAC addresses on multiple switches and different VLANs. Refer to [figure 3](#) and [figure 4](#):

Note that in [figure 3](#) and [figure 4](#), if all switches are Series 5300XL switches, then you can use either topology.
