Release Notes:

Version E.08.01 Software

for the HP ProCurve Series 5300XL Switches

Release E.08.01 supports these switches:

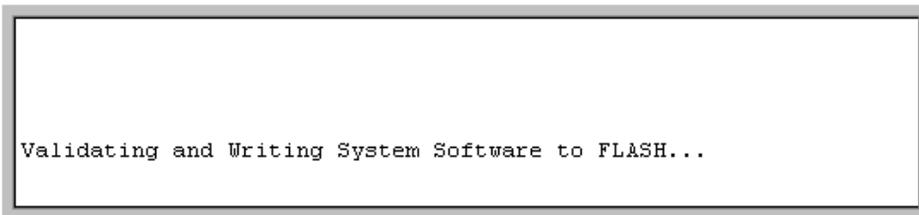
2. When the switch finishes downloading the OS file from the server, it displays this progress message:

Figure 1. Message Indicating the Switch Is Writing the Downloaded Software to Flash Memory

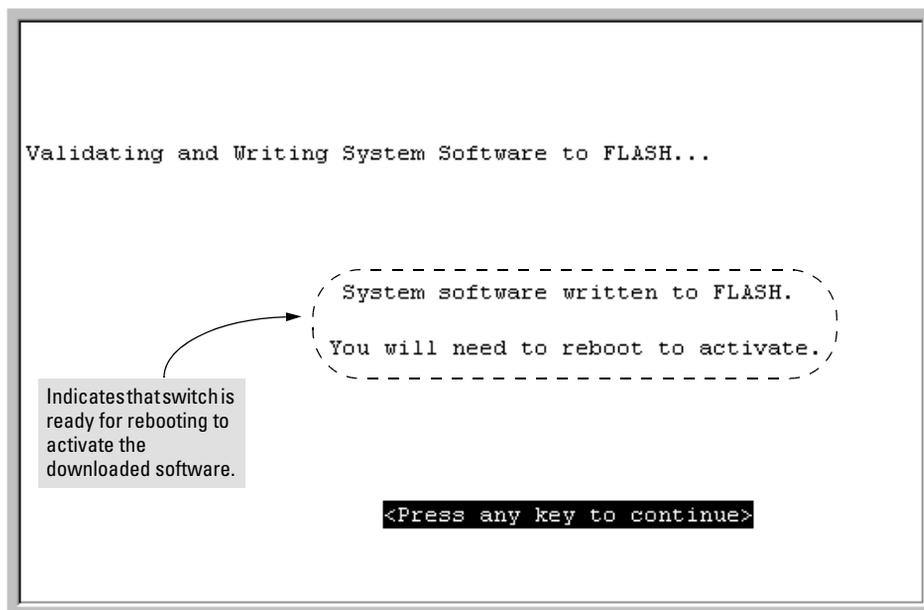
3. After the switch writes the downloaded software to flash memory, you will see this screen:

Figure 2. Message Indicating the Switch Is Ready To Activate the Downloaded Software

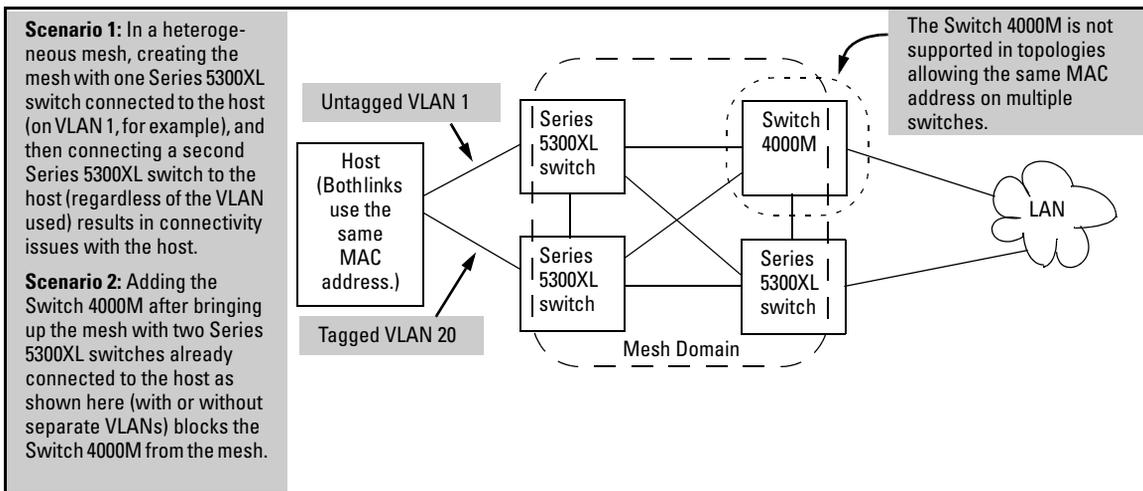
Figure 3. Example of an Unsupported Heterogeneous Topology Where Duplicate MAC Addresses Come Through Different Switches (Regardless of the VLANs Used)

When Series 5300XL switches running software release E.07.2x or greater are placed in backward-compatibility mode, they can operate in switch mesh domains that include HP ProCurve 1600M, 2400M, 2424M, 4000M, and 8000M switches. However, because these older switch models use a single-forwarding database, a heterogeneous domain must be free of duplicate MAC addresses on multiple switches and different VLANs. Refer to [figure 3](#) and [figure 4](#):

Note that in [figure 3](#) and [figure 4](#), if all switches are Series 5300XL switches, then you can use either topology.

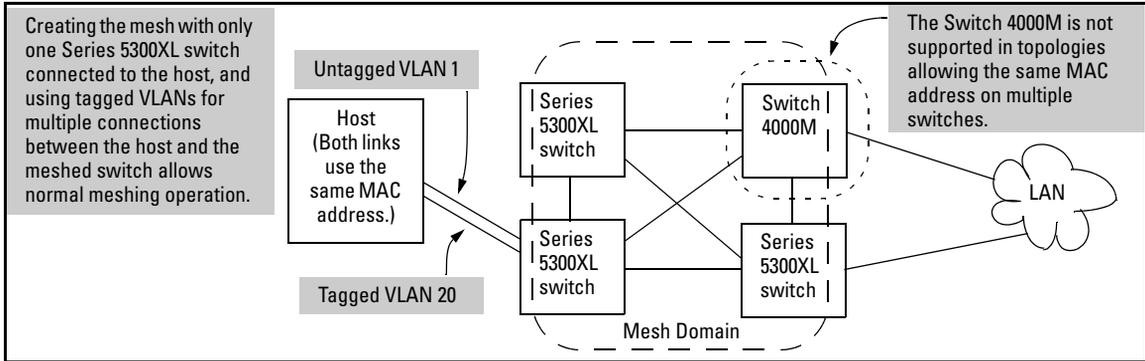
Figure 4. Example of a Supported Heterogeneous Topology Where Duplicate MAC Addresses Come Through Different VLANs on the Same Switch
