Release Notes:

Version I.07.60 Software

for the HP ProCurve 2800 Series

Release I.07.60 supports these switches:

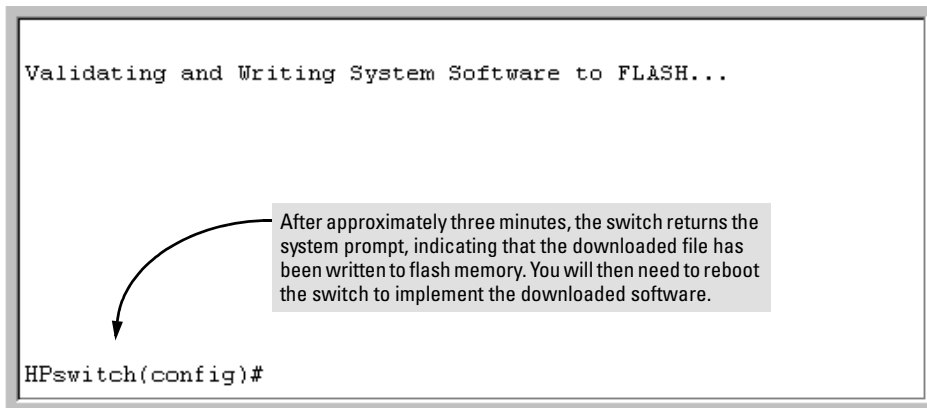
3. After the switch writes the downloaded software to flash memory (approximately three minutes), you will see this screen:

Figure 1. The System Prompt Indicates the Switch Is Ready To Activate the Downloaded Software

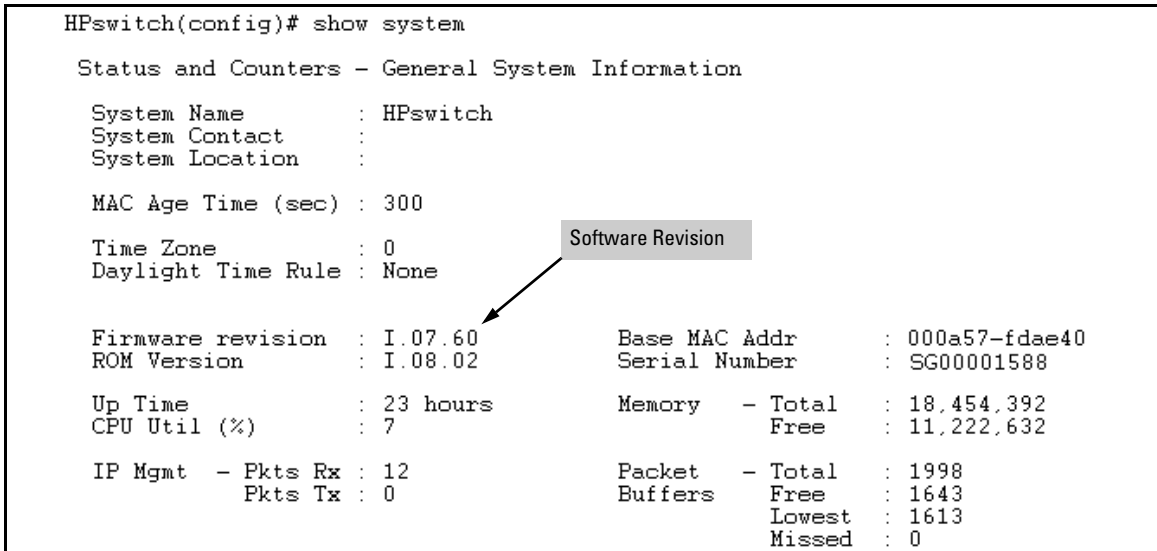
Figure 3. Example of Using the CLI 'show system' Command to Verify the Software Revision
