Release Notes: Version H.07.56 Software *for the ProCurve Series 6108 Switches*

5991-2157
May 2005

ProCurve Switch 6108 (H.07.xxx only) (J4902A)

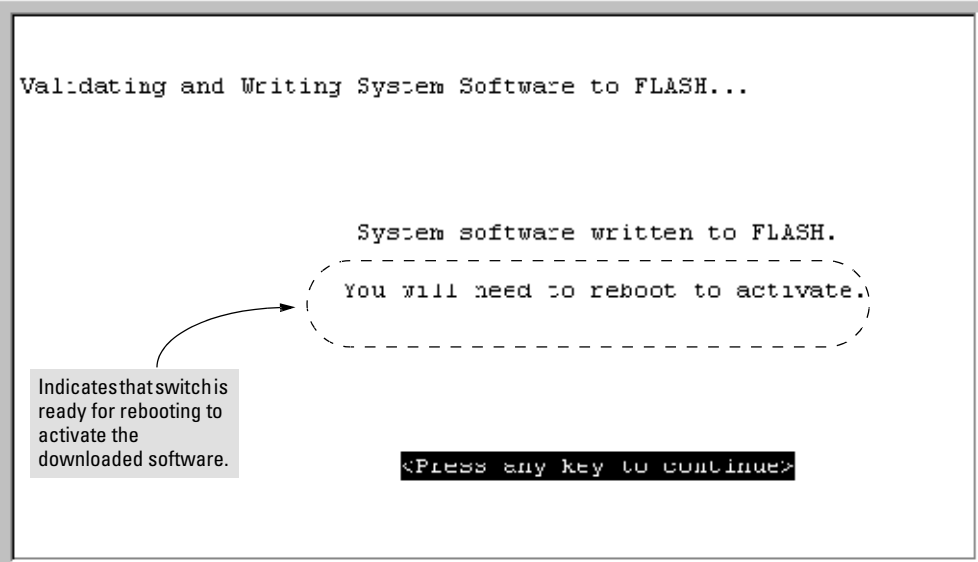
Figure 1. Message Indicating the Switch Is Writing the Downloaded Software to Flash Memory

3. After the switch writes the downloaded software to flash memory, you will see this screen:

```
Validating and Writing System Software to FLASH...

System software written to FLASH.
You will need to reboot to activate.
